Name Of Dam: LOWER NORTON RESERVOIR

Location: WISE COUNTY, VIRGINIA

Inventory Number: VA 19507

# PHASE I INSPECTION REPORT

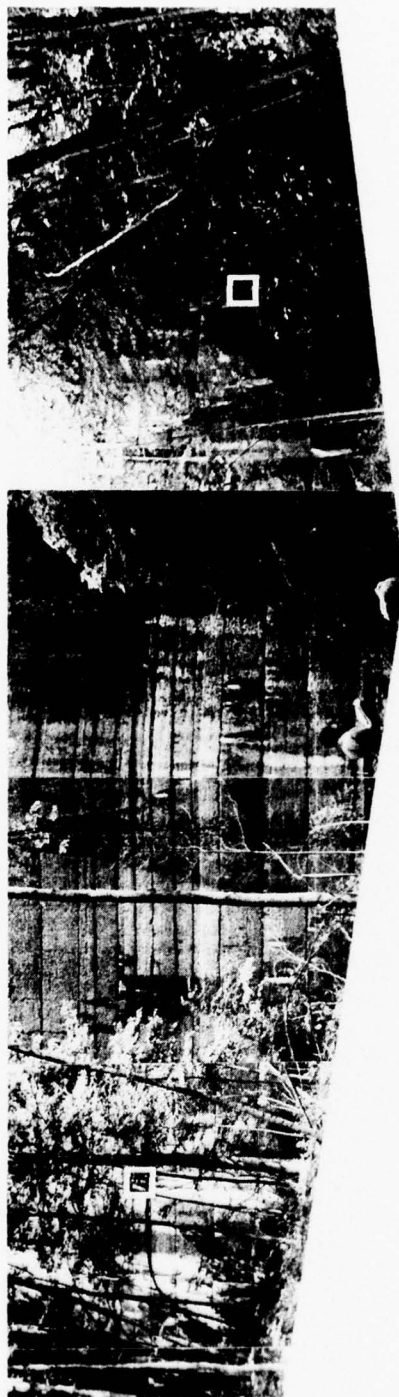
3.1.2 Dam: It appears from the form-work impressions that the dam was constructed in horizontal lifts of 5 feet or less. Significant leakage of water was noticed at at least three different places. It appears that water is coming out of the construction joints. Three of these leakage spots were in the central overflow section of the dam. There were areas of severe scaling of the concrete, and erosion at horizontal joints was common.

MOSAIC OF DOWNSTREAM FACE - NOTE 3 SEEPAGE AREAS INDICATED BY WHITE SQUARES

b. The areas experiencing leakage should be continuously monitored and investigated starting immediately, and necessary repairs carried out within 6 months to stop the leakage. However, in the meantime, if a significant change in the leakage is noted, then appropriate measures should be taken immediately.

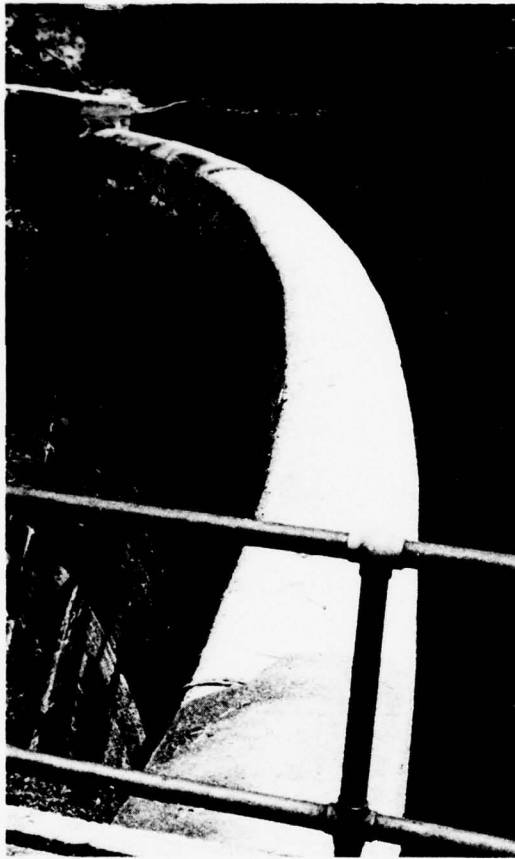
The dimensions of the overflow section of the dam generally agreed with the drawings. There was some spalling of concrete on the spillway crest except for 10-foot sections on both ends of the structure.

VIEW OF SPILLWAY CREST - NOTE  
SEPARATION OF TOP LAYER ALONG  
ENTIRE CENTER PORTION AND  
VEGETATION EMBRACING RIGHT  
SIDE OF DAM

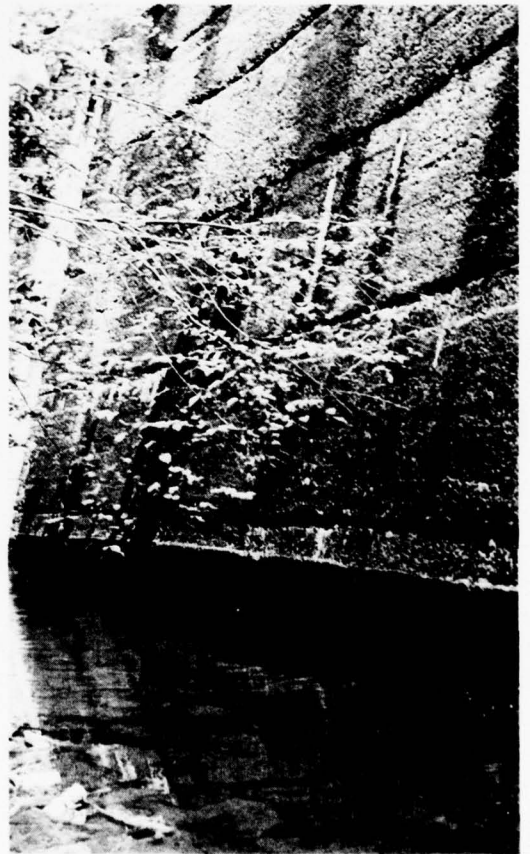
DETAIL OF DOWNSTREAM BASE - NOTE  
SEVERE CONCRETE SCALING, ESPECIALLY  
AT CONSTRUCTION POINTS

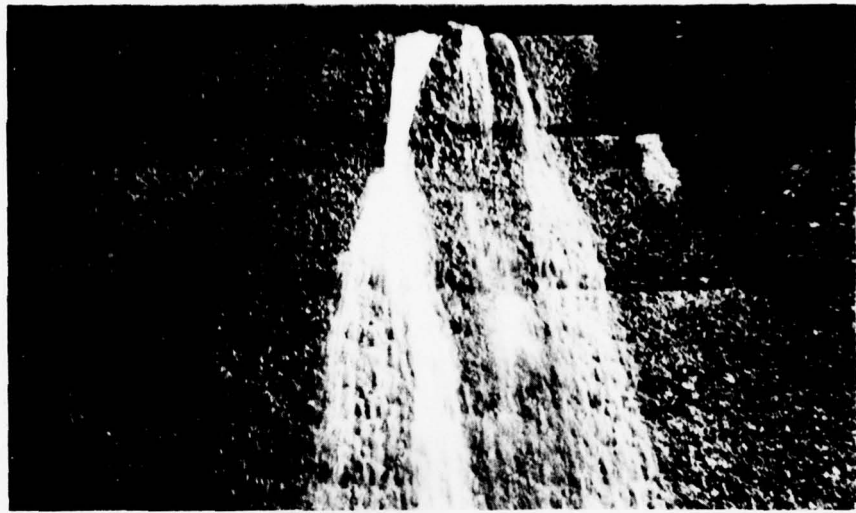
CLOSE-UP OF LEAK OF THE OVERFLOW PORTION.  
NOTE: CONCRETE EROSION AROUND LEAK

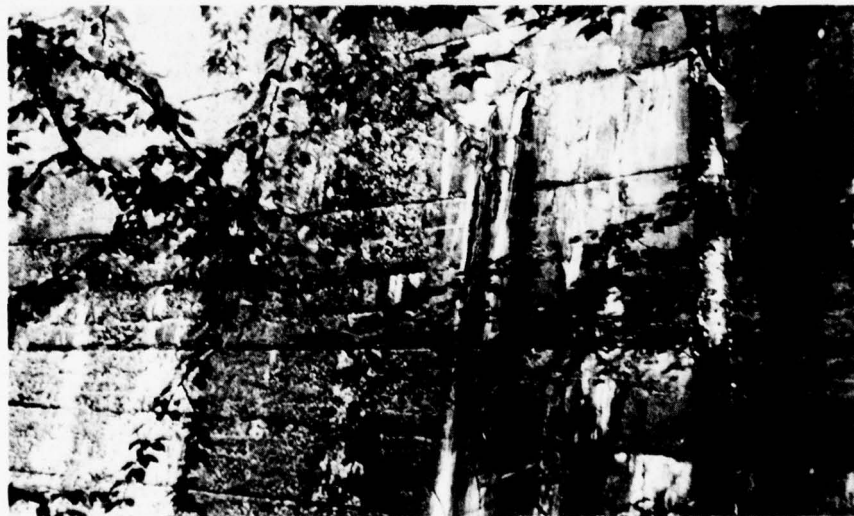
CLOSE-UP OF LEAK AREA IN FACE OF DAM  
NOTE: CONCRETE EROSION AROUND LEAK

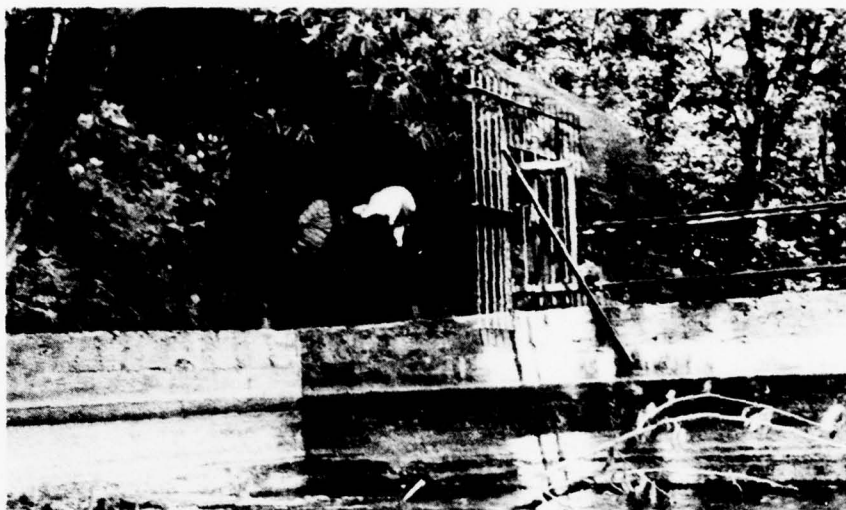
d. Large trees have grown on both the right and left abutments of the dam, which may deteriorate the strength of the load-bearing rock strata.

LEFT ABUTMENT - NOTE LEDGE ROCK  
BEDDING AND GROWTH OF TREES

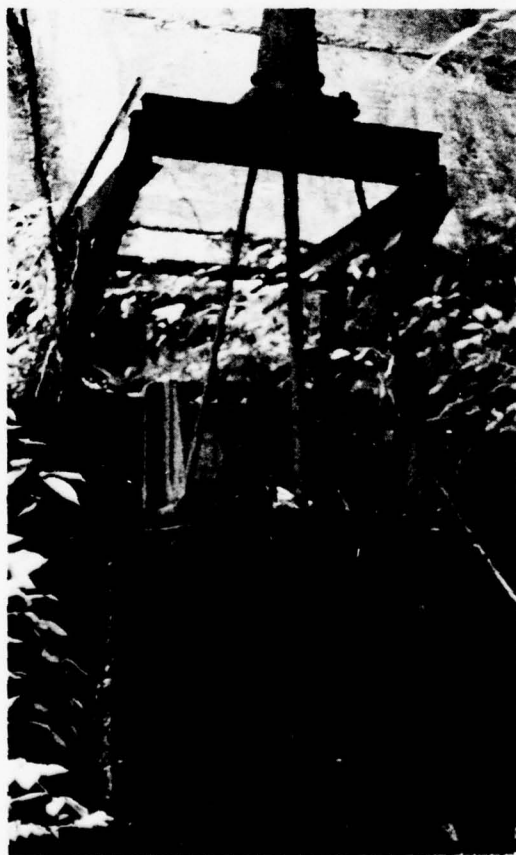
Although the available drawings do not show it, a sluice gate about 3 feet in diameter was installed above the downstream grade to the left of the overflow section, apparently to drain the reservoir. This valve is rusted and filled with sediments; therefore, it is not operational. The handwheel has been removed from this valve.

THREE-FOOT DIAMETER SLUICE GATE -  
OPERATING WHEEL HAS BEEN REMOVED.
